# Arboricultural Survey Report 2023

Edmunds Green, Edmund Close, Meopham, Kent. DA3 0NB

**Report Ref:** AS0250/08-23  
**Report Date:** 24<sup>th</sup> August 2023 (valid for one year from survey date)

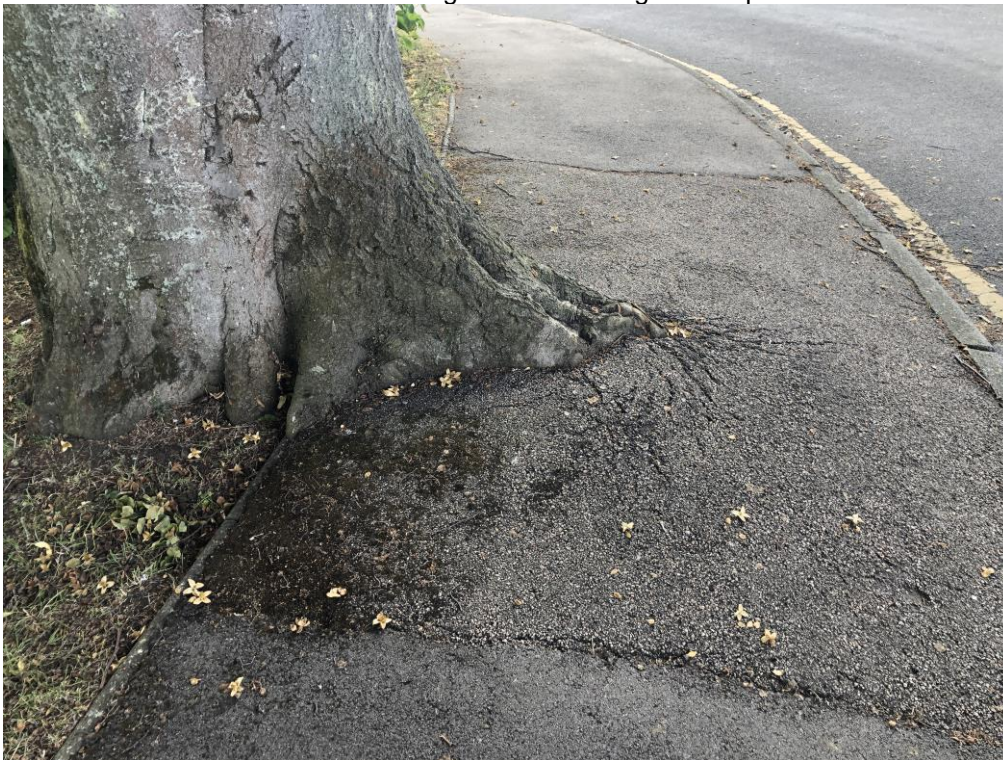
| Tree Number | | T2 | Tree Species | Common Beech<br>(Fagus sylvatica) | | Age | Mat | Phys Cond. | G |
|--|---|---|---|---|---|---|---|---|---|
| Buttresses | | Large buttress root to the west causing displacement and lifting of the public path. Evidence of past tarmac replacement around the base of the tree due to surface damage by root growth. <i>(Please refer to photo 1 at Appendix D)</i> | | | | | | | |

**Photo 1** – Base of Beech T2 showing buttress damage to footpath surface and obstruction.

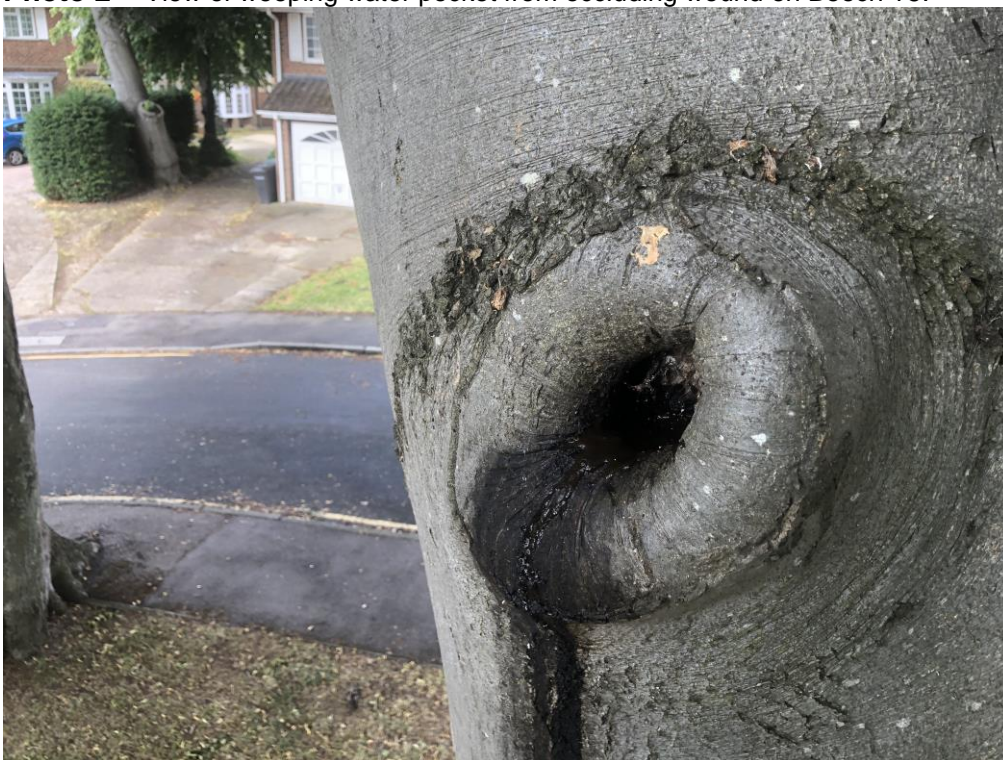
**Photo 2** – View of weeping water pocket from occluding wound on Beech T5.
